Report No.
SSRP-2001/24
FINAL

**SEISMIC PERFORMANCE OF
PRECAST SEGMENTAL BRIDGE
SUPERSTRUCTURES**

Final Report Submitted to Caltrans under Contract No. 59A0051

Department of Structural Engineering
University of California, San Diego
La Jolla, California 92093-0085

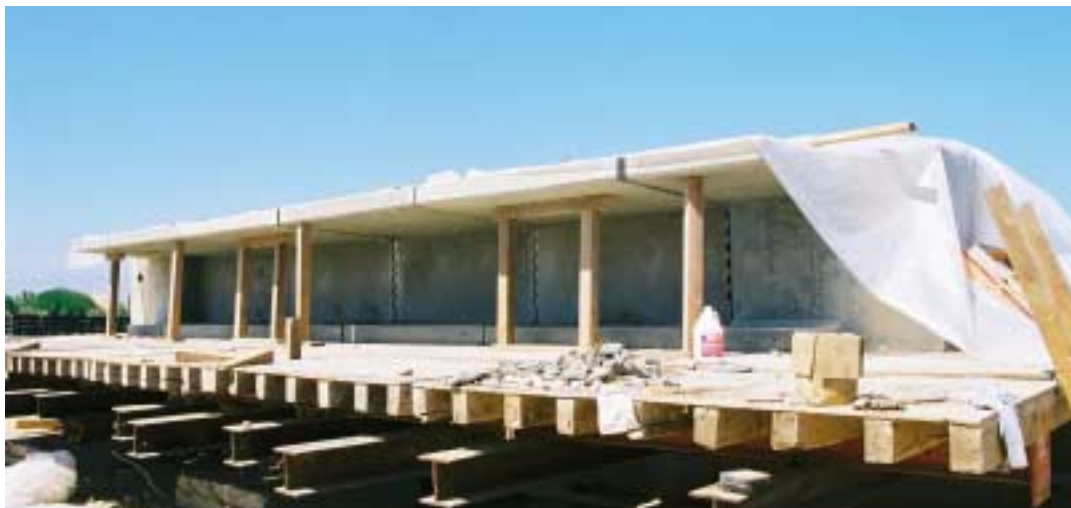
Figure 2-10 Typical test unit after construction with segments separated

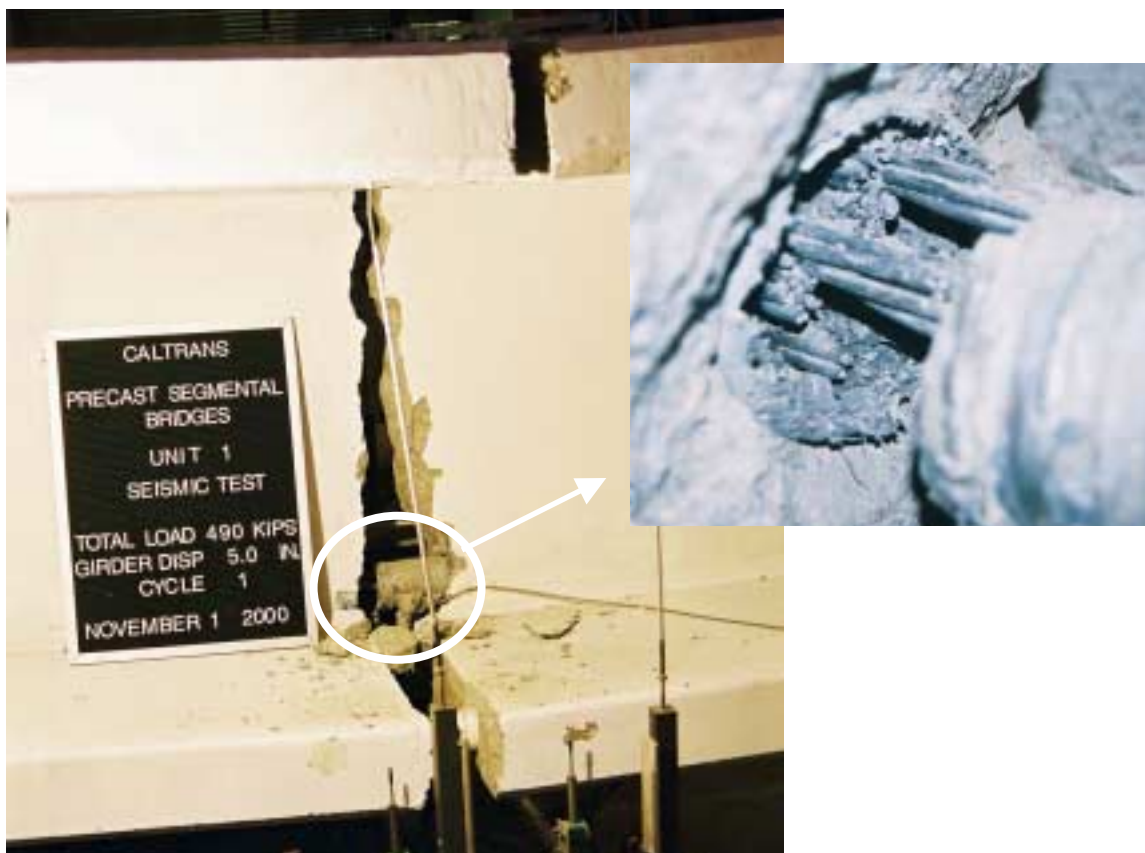
Figure 3-6 Unit 100-INT, West side of joint J3 after failure with tendon close-up

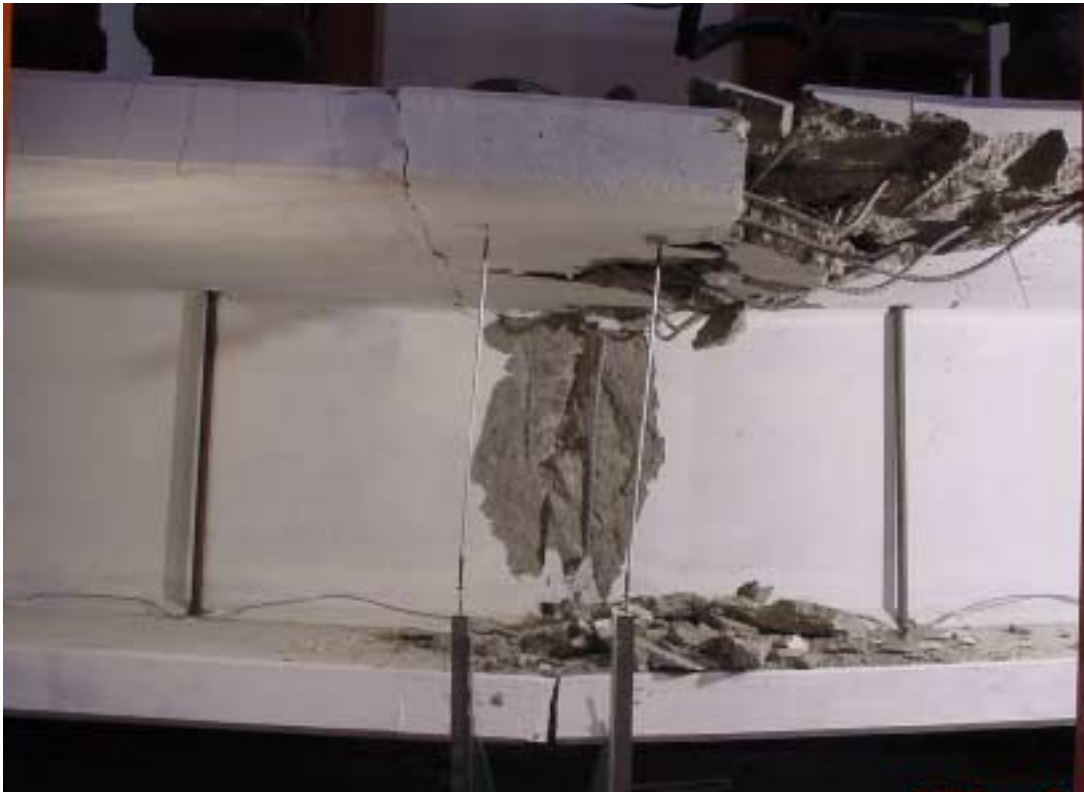
Figure 3-12 Unit 100-INT-CIP joint J3 after failure

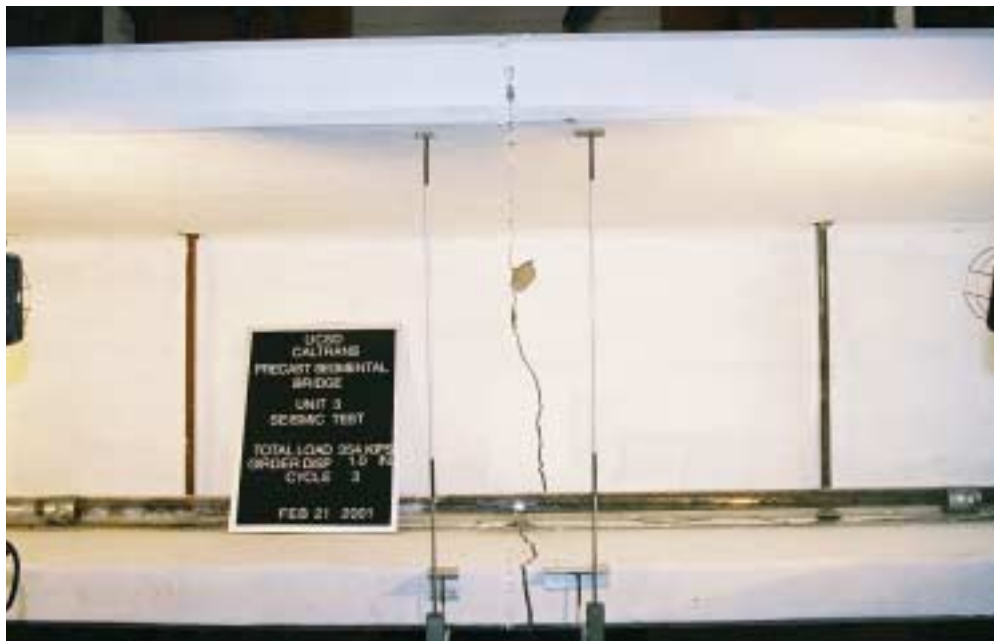
Figure 3-13 Unit 100-EXT, West side of joint J3, $\Delta=+1.0$ in. (25.4 mm)

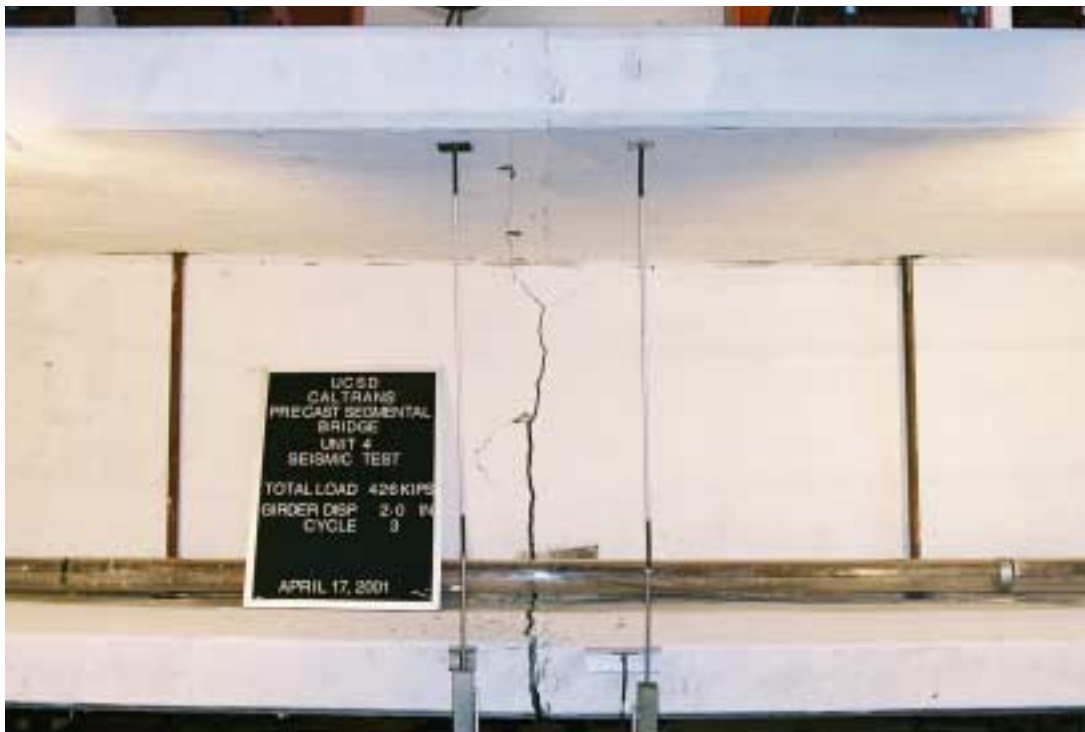
Figure 3-19 West side of joint J3 of Unit 50-INT/50-EXT, $\Delta=+2.0$ (50.8 mm)

In the upward loading direction cracking at J3 occurred during the -0.5 in. (-12.7 mm) displacement cycle. Spalling of the bottom surface was observed during the -3.0 in. (-76.2 mm) displacement cycle. Joint J3 was the only one to open and opened widely in the upward direction, similar to the previous test units.

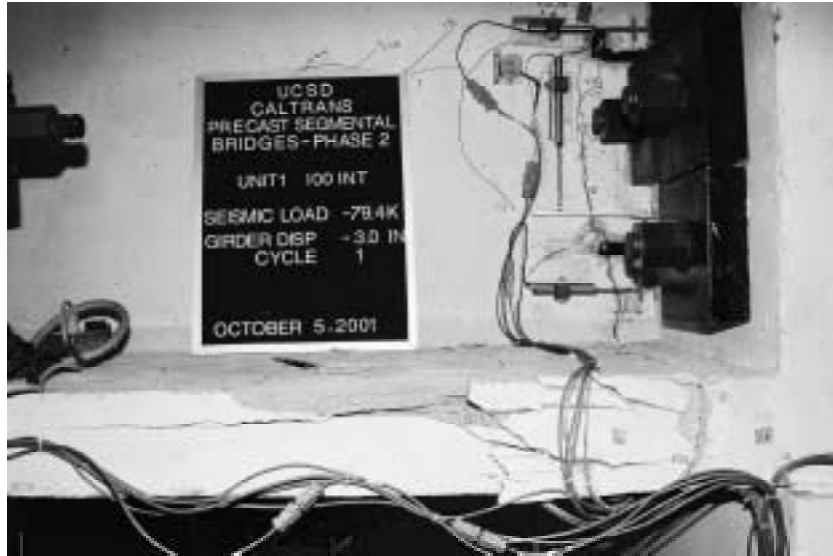
Figure 6-4 Cracks in Unit 100-INT at 3 in. (76 mm) upward displacement

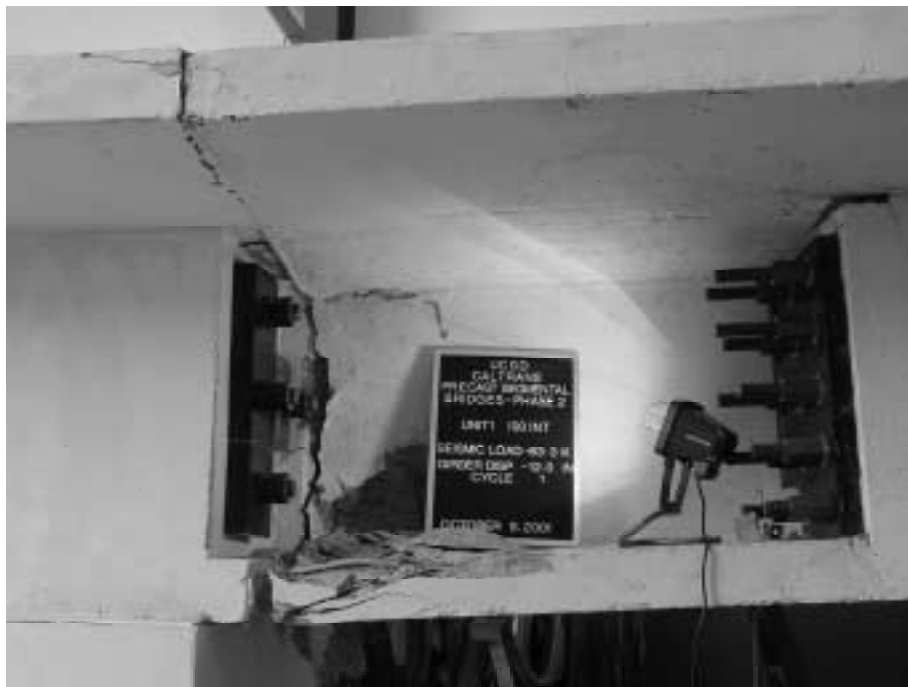
Figure 6-7 Compression failure of Test Unit 100-INT under upward loading

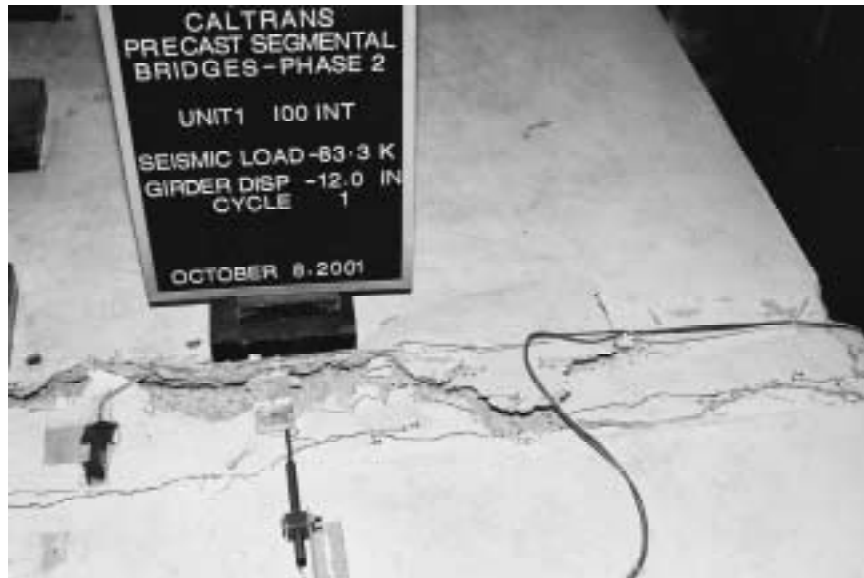
Figure 6-8 Compression failure of the deck in Test Unit 100-INT

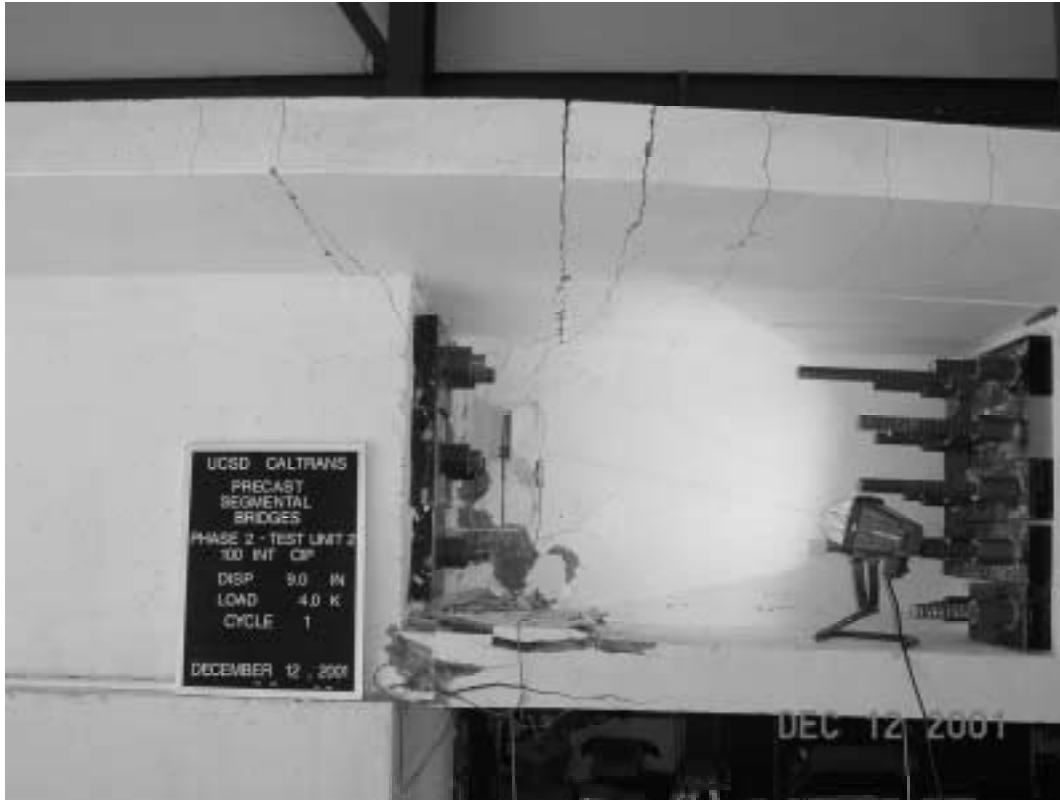
Figure 6-16 Compression failure of Test Unit 100-INT-CIP under downward loading at 9 in. (229 mm)

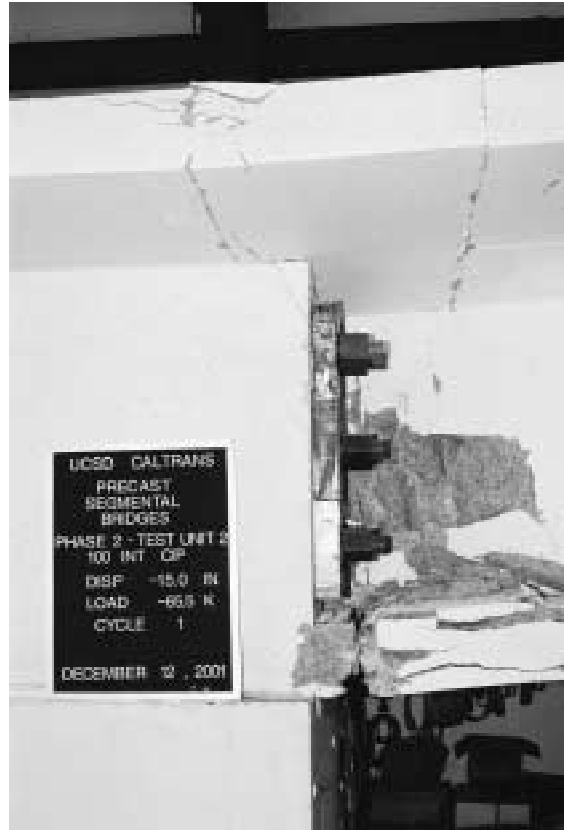
Figure 6-17 Test Unit 100-INT-CIP at 15 in. (381 mm) upward displacement

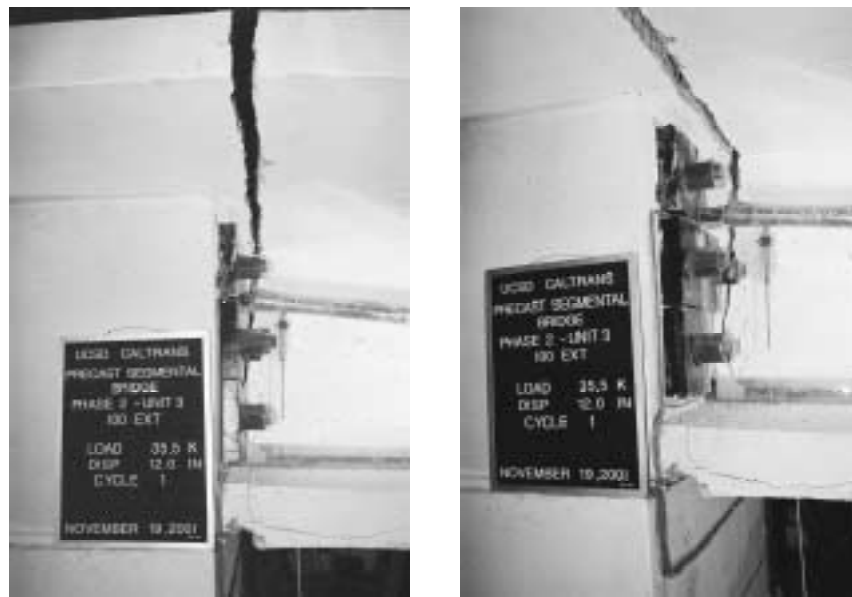
Figure 6-23 Test Unit 100-EXT at 12 in. (305 mm) downward displacement

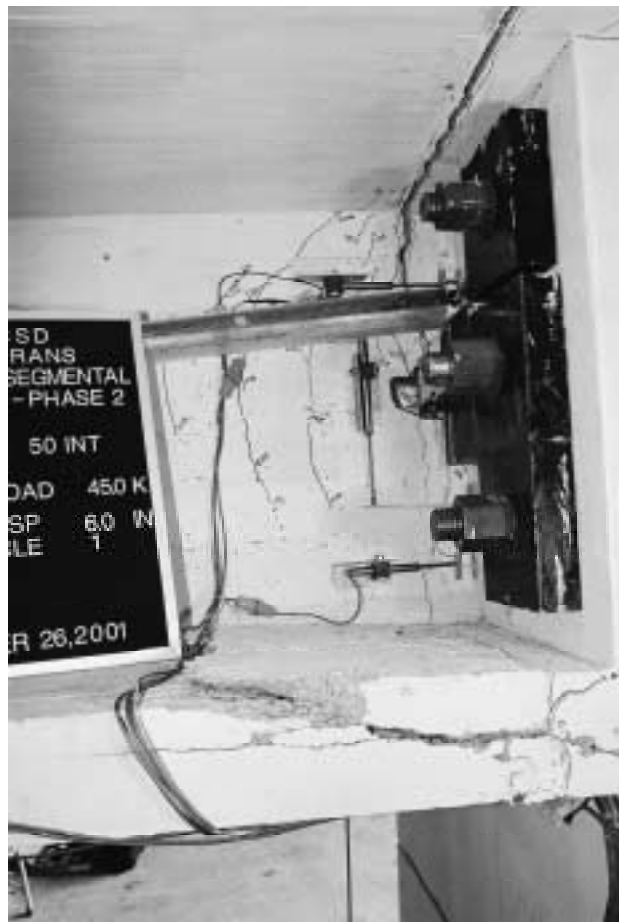
Figure 6-31 Compression softening of the bottom slab of Test Unit 50-INT/50-EXT at 6 in. (152 mm) downward displacement

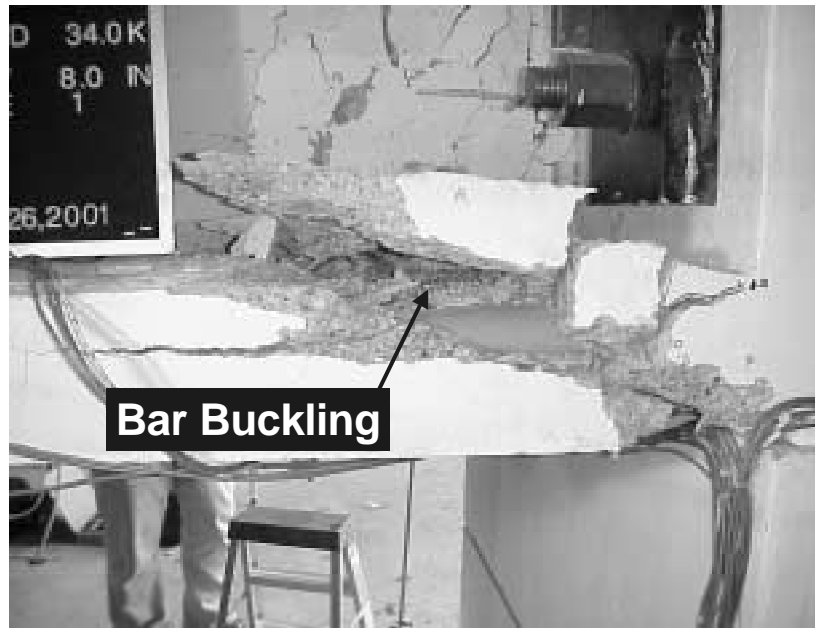
Figure 6-33 Close-up of the compression failure of Unit 50-INT/50-EXT

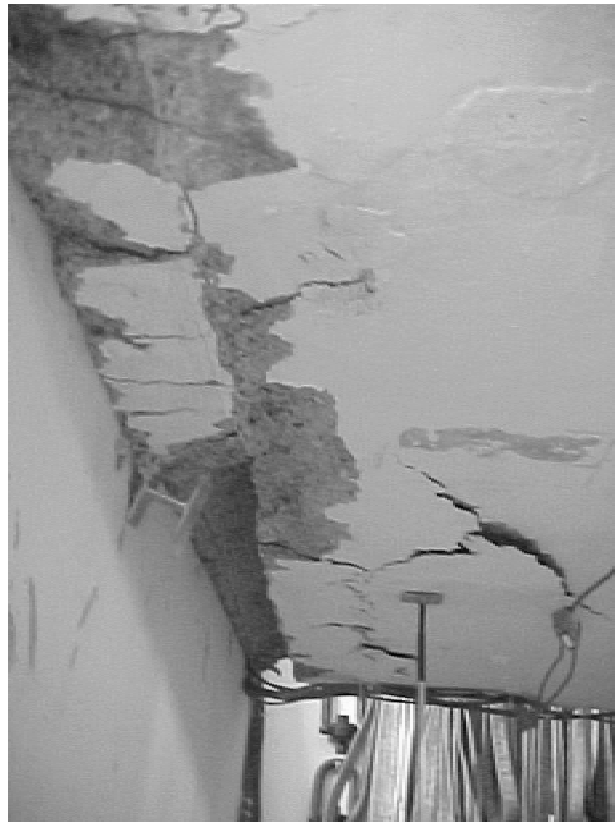
Figure 6-34 Compression failure at the bottom slab of Test Unit 50-INT/50-EXT

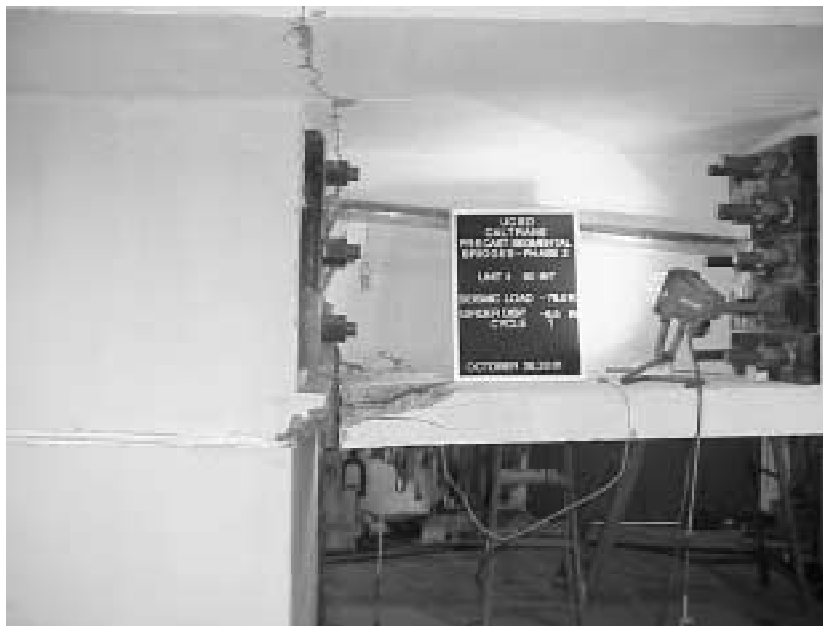
Figure 6-35 Unit 50-INT/50-EXT at an upward displacement of 7.3 in. (185 mm)
